Manhole Inspection Summary

Manhole # S55I__001MH

Insp Date: **5/29/08 1:17 PM**

Location Address: **518 s highland ave**

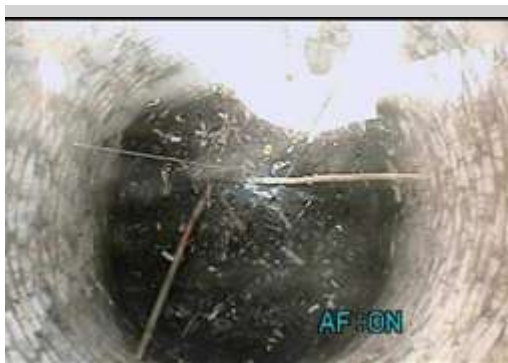
Defect 2

Count: **3** Missing: **3** ☒ **Corroded**

steps

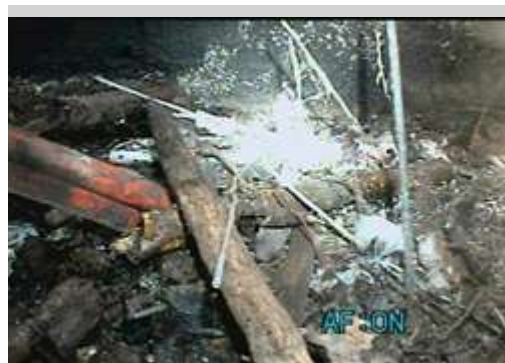
Defect 1

channel debris
